Moss Engineering

We completed the inspection of your engine on the 13th and 14th of this month.
These conclusions are arrived at after study of a considerable number of individual measurements.

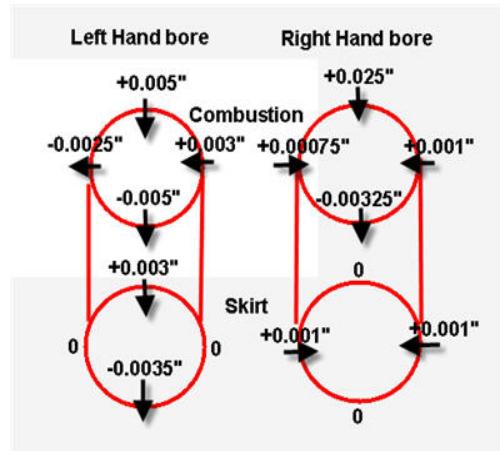
The Results of this test were as follows:

The 'fore and aft' deviations are unimportant, they being in the axis of the big end assembly. The sideways deviation on the Left hand cylinder is more significant as there will be the tendency for the rod to slide sideways under load on a pin that is not completely square to it.

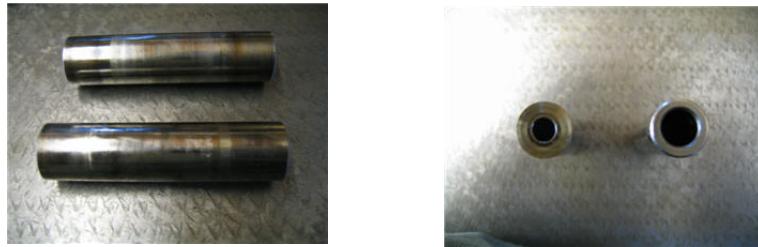
Both Pistons measurements suggest the practice of squeezing the skirts to take up excess clearance in the thrust direction. This increases the clearance in the pin axis, which reduces the control upon the pistons movement normally exerted by the bore.

The Piston pin bores are between 0.0017" and 0.002" oversize and the pins are 0.0007" and 0.0008" down respectively.

The Pins also show signs of long wear patterns, from the movement of the little end along them in use. The Right Pin also shows greater signs of heat in use.

The Pins are also very heavy in Section and weigh 90g each as compared to the ones we use which are 70g. This extra weight will increase loadings under higher rev conditions.

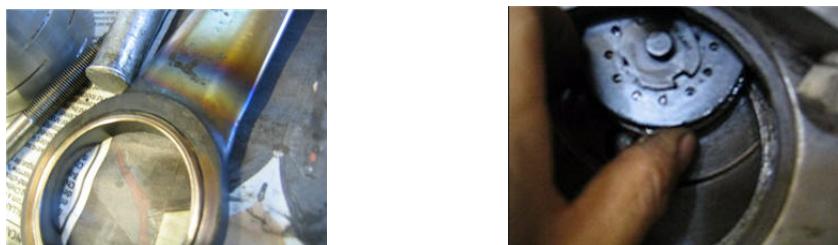
The Right Hand Rod deviated 0.0065" from parallel and 0.0065" twist. The Big end does not look so good!

Click on the pictures to see what was happening:

The bluing is a sign of the intensity of the heat that was created in the failure of the big end assembly. This requires a complete big end overhaul, and little end work.

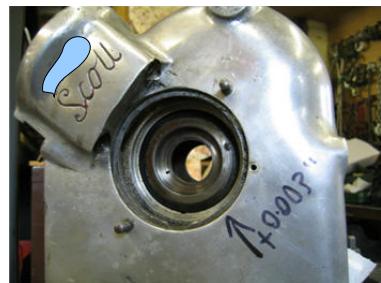
Mixing Cups prepared in different ways can invite inaccuracy and after measurement there was a positional difference relative to the block face of $0.003"$.

As the Right Hand Cup is already damaged at the Gland face, It is our suggestion that this be replaced with a pre ground cup, which will ,as on the left side, rely on the position of the crankcase main bearing cup bores for positional accuracy.

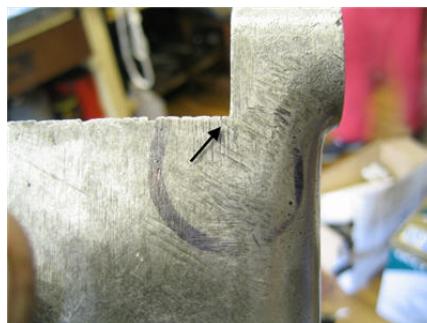
The right hand lower rear mounting lug is definitely cracked and there is also the slightest of evidence that the left hand side one is too. This will need to be welded.
